# 400 feet, 53 stories

How structural engineer was able to squeeze as many floors as possible under restrictive height. By Steven M. Baldridge, P.E., S.E., LEED AP

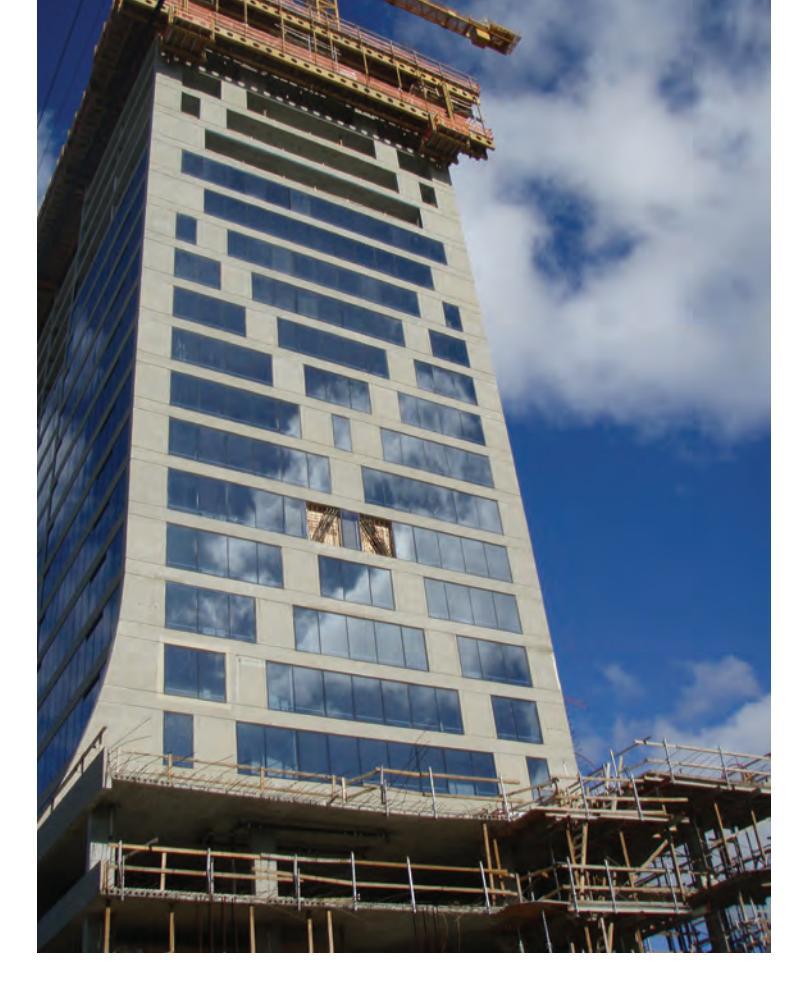
TOP: Leave-out panel at x-brace (overall). BOTTOM: ETABS analysis model superimposed over Architect's rendering.

Based on the panel proportions, the team determined that the construction sequence would have to be altered to reduce the amount of gravity load being induced into the diagonals. This required a panel to be left open in each of the lower two x-braces until the building reached full height. In order to allow interior finish work of the end units at these locations to proceed without delay, the glazing was installed around the leave-out panel. The final infilling of the panel had to be performed without damaging either the completed interior finishes or the surrounding glazing system.

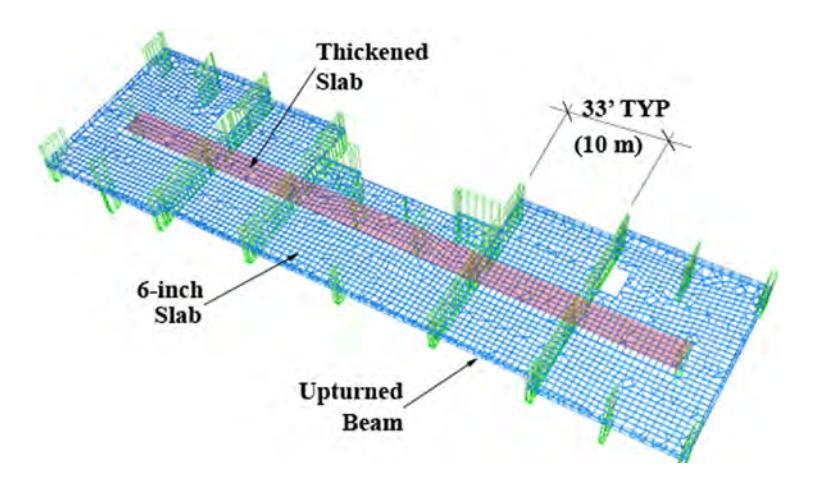
TOP: Concept FEM floor model. BOTTOM: Construction resumes with new contractor and forming systems. *Photo by www.vitopalmisano.com.*

While relatively simple in plan, the deflection characteristics of a floor system with varying spans and element thicknesses warranted the increased accuracy of a three-dimensional finite element analysis to verify performance of the thin slab systems. The final configuration allowed the required 8-foot by 6-inch floor-to-floor height in the residential units and an approximately 8-foot floor-to-floor height in the parking areas in levels split down the length of the project 4 feet apart, connected by short ramps for vehicle circulation up the building.
